DARDANUP PARK PTY LTD

DARDANUP PARK

ENGINEERING SERVICING REPORT

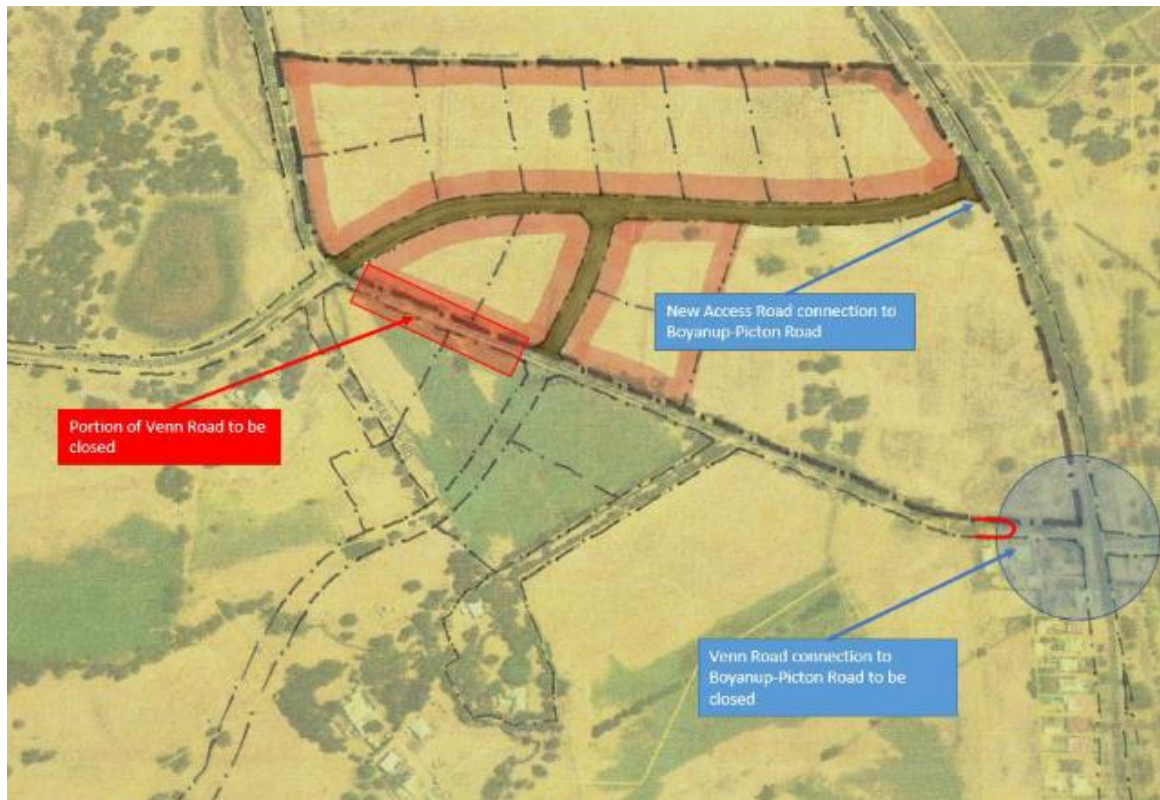
Traffic Impact Assessment completed by Cardno has indicated that it would be desirable for a future extension of Keenan Road through the northern Lot 26 once it is developed although not necessary for this development. This will change the ultimate exit from the development on to the Boyanup Picton Road to a 3 way intersection. The roads will be constructed to a sealed standard with open drainage on one or both sides of the road.

Figure 3: Extract from Cardno TIA showing future road Extension

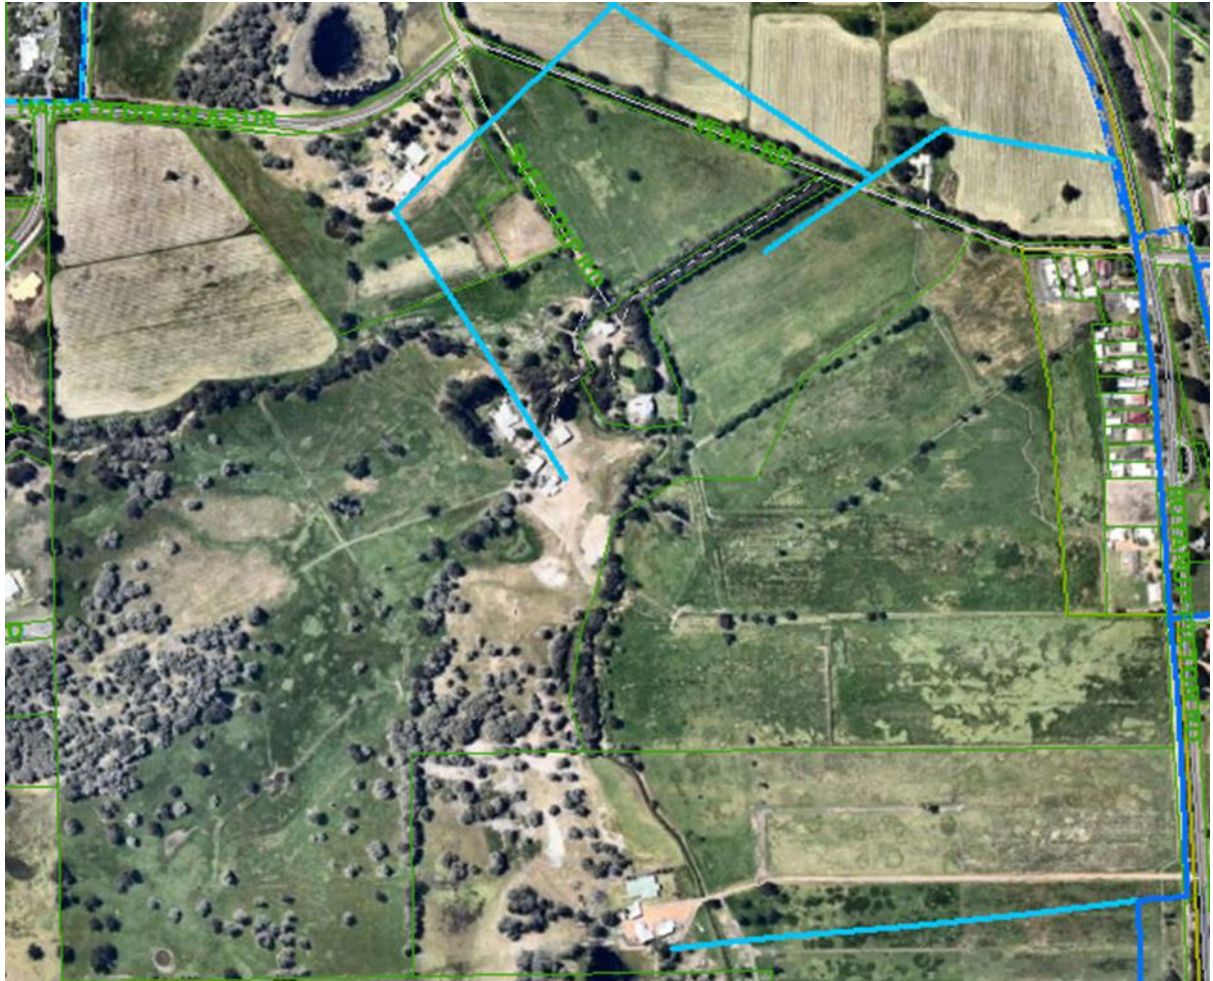
Figure 4: Present HV Network Dark blue is three phase. Light blue is single phase.

In country areas there is generally capacity in the Zone Substations. However, some of the 22kV Distribution lines are of age and the line conductors may be at capacity, thus any additional load could trigger a line conductor upgrade. This can only be determined through a request to Western Power to model the existing Distribution network with the new development load on the network. The study could also model potential natural load growth on the network to determine if the network would need upgrading.
